Manhole Inspection Summary

Manhole # S25GG_011MH

Insp Date: **9/30/08 10:14 AM**

Location Address: **1210 PRESSTMAN ST**

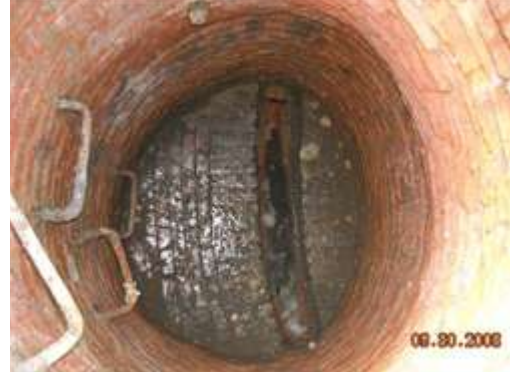
Top View

Infiltration: ☐ None ☐ Joint ☐ Cracks ☒ **Mortar** ☐ Roots ☒ **Wall**

Steps Count: **5** Missing: **0** ☒ **Corroded**

Surcharge ☒ **Evidence Of Surcharge** Depth: **4.5** (ft.) ☐ Active Surcharge Present

Barrel infiltration. Corroded steps.
Evidence of surcharge - Bench debris.

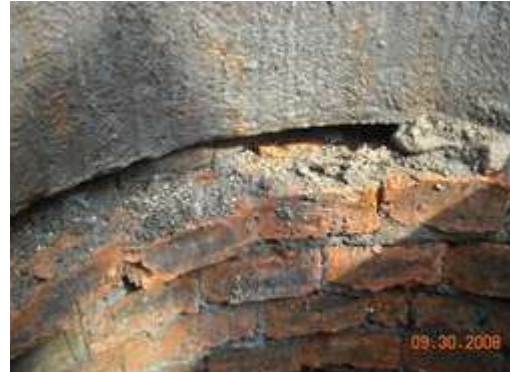
Defect

Frame Offset: **1.5** (in.) Condition: ☐ Sound ☐ Cracked ☒ **Leaks**

Condition: ☐ Sound ☐ Cracked ☐ Root Intrusion ☐ Loose Brick ☒ **Deteriorated**

Infiltration: ☐ None ☒ **Joint** ☐ Cracks ☒ **Mortar** ☐ Roots ☐ Wall

Frame leaks. Frame offset. Adjustment
deterioration and infiltration.
